SUSSEX INDUSTRIAL HISTORY

THE RESTORATION OF A TILE KILN AT PIDDINGHOE, EAST SUSSEX (TQ 432632)

By E. W. O'Shea

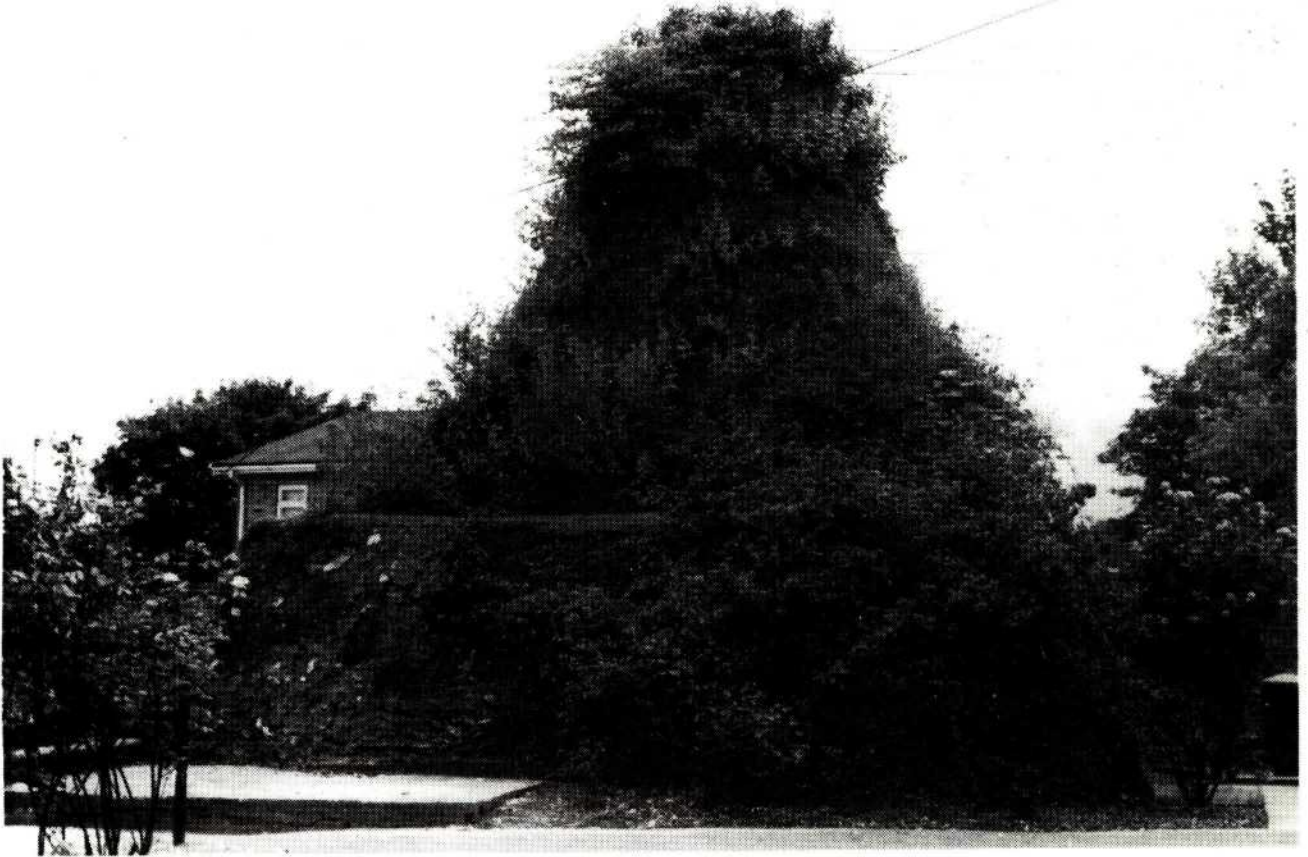
Fig.2 Before Restoration.

In the meantime part of the flint rubble enclosing wall had fallen from the east end of the upper part of the kiln, causing a great deal of alarm to the resident of the bungalow only one-and-a-half metres from the back of the kiln. First-aid repairs were of immediate importance and measures were agreed upon, based upon my proposal that a double course of reinforced brickwork should be built to span the two brick piers behind the furnaces which supported the pair of arches over the stoke-holes. Following a serious illness, I felt it unwise to assist physically in this work, but I agreed to visit and advise when the work was due to commence. Because of their concern about accidents the owners decided to carry on with the repairs and my recommendations were not adhered to and in my opinion the result is most unfortunate, both structurally and aesthetically. A reinforced concrete beam had been substituted for the reinforced brickwork which was completely out of character with the rest of the work. With reinforced concrete, because of the varying co-efficients of expansion of steel and concrete, the corresponding cross sections of steel and concrete must be finely balanced. In this case the amount of steel was so great that it could be sufficient to cause the beam to fail under its own weight.

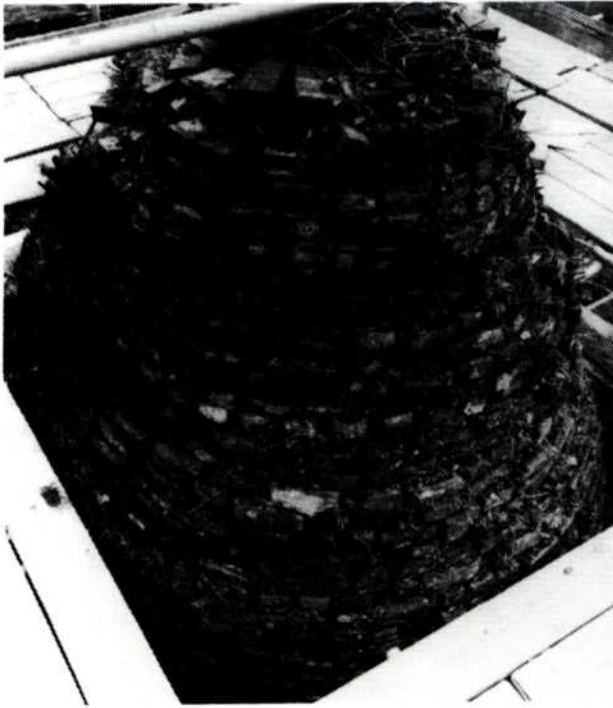
Fig.5 Top of Kiln Before Restoration

Apart from the hawthorn, bush ivy had also caused considerable damage establishing roots in large clumps around the base of the cone. Some of the weeds had penetrated the full thickness of the wall and as the vegetation was removed so the full extent of the damage was revealed. Cracking was most extensive within the lower third of the cone adjacent to corners and where the batter was at its greatest extent, the south side being the worst affected. Close to the south-east corner, cracks from 2 to 6cm wide followed the perpend up for a distance of 1.5 m and a panel about 1.5 m square had dropped forward 3cm and was likely to collapse at any time. All corners were affected to some degree, undoubtedly due to the poor bonding which could not have been avoided with the very tight radius. Daylight was visible in a number of cases.

The top course consisted of nothing but a half circle of creasing tiles and from our later experience it was reasonable to suppose that this was the original top of the cone, the tiles being there to change the batter to produce the vertical shaft. It was not until five courses had been removed that a complete circle of work could be examined. The inward cant was now definable and whilst the cone remained a near circle this remained constant, but as it widened out the cant varied, particularly on the corners. Parts of a broken strap was found at the fifth course and was preserved and recorded.
