Sussex Windmills and their Restoration

– a 1970s perspective

TWENTY NINE

SUSSEX WINDMILLS AND THEIR RESTORATION – A 1970s PERSPECTIVE

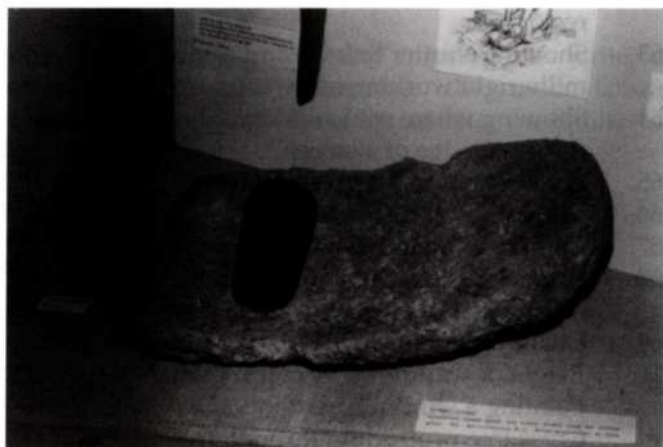
Fig. 1 Saddle Quern

In the Neolithic cultures and frequently in the Late Bronze Age and Early Iron Age man discovered that by rubbing the grain between two stones he was able to grind it into usable flour. This was the beginning of what was to be known as a quern. The earliest form of quern was called a saddle quern which consisted of a lower stone, having the rough shape of a saddle, and an upper stone that was pushed backwards and forwards by hand.

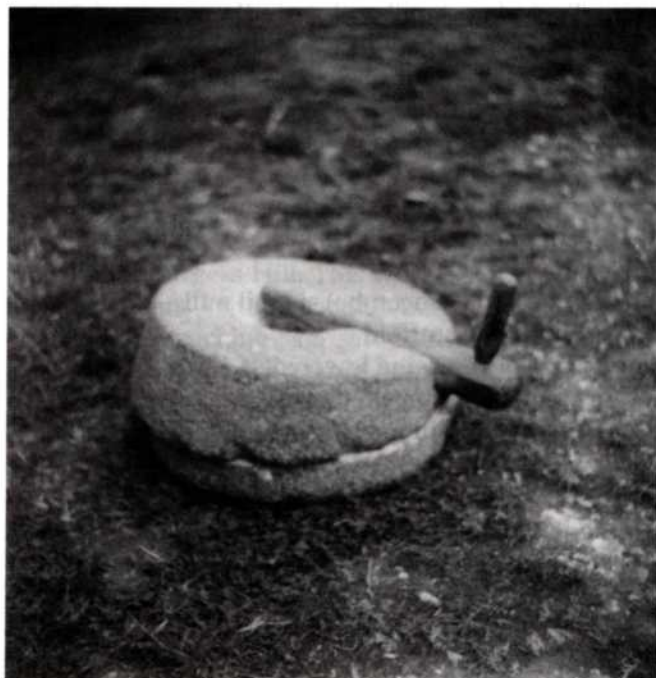
Fig. 2 Rotary Quern

The saddle quern was in use in Britain c.2000 B.C., and was not superseded by an improved version the rotary quern until c.100 B.C., when it was probably introduced by Belgic invaders. (ref. *Archaeology A to Z*). The rotary quern consisted of two stones, the upper one pivoting on a spindle sticking up from the centre of the lower stone and revolving on it. There was a hole in the upper stone into which the grain was put, and it had a handle for turning. Variations of these are still used today by primitive tribes.

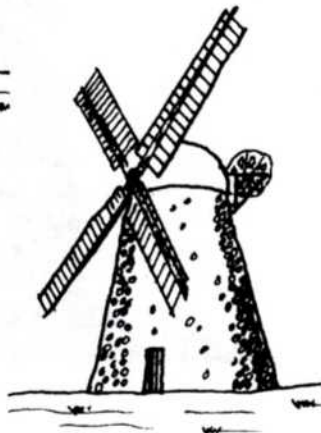
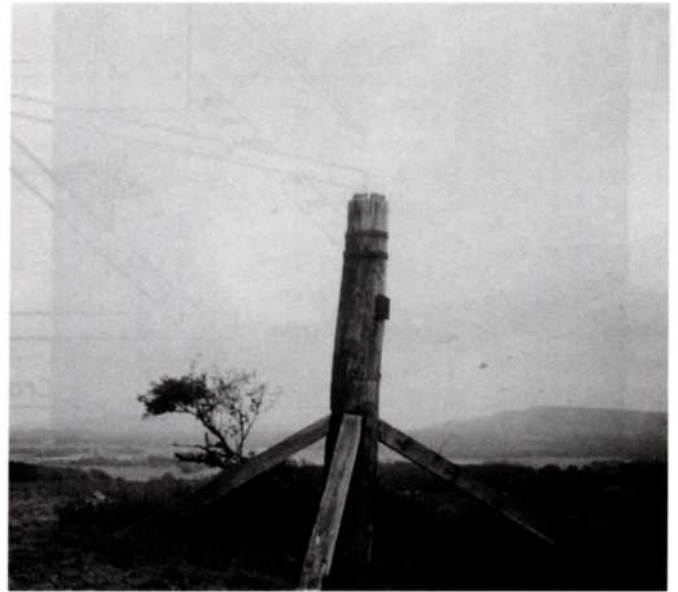
Fig. 7 The remains of Ringmer Post Mill

The post mill, being the earliest recorded type of windmill as we know them, was of a very simple design. It comprised a large wooden "box-like" structure, which housed the "machinery". This structure was supported by an open trestle built of large baulks of timber in the form of a cross, which supported a *centre post* on which the whole of the body of the mill revolved. The remains of the Ringmer post mill shows the centre post being supported by the *quarter bars*.

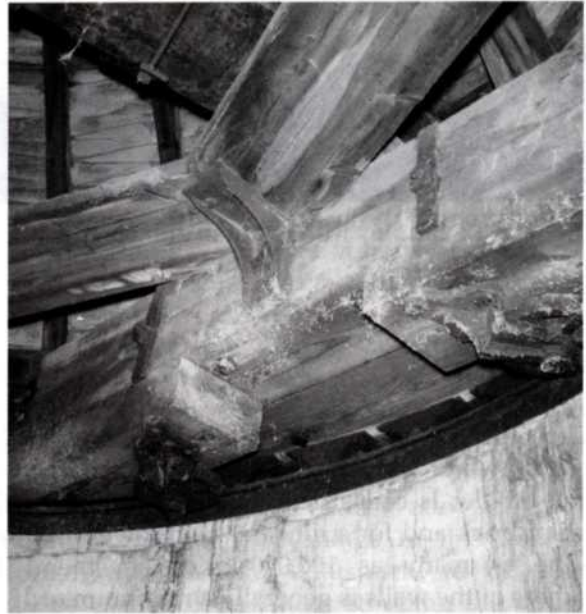
Fig. 11 Curb and centering wheels

The cap sits on the body structure on what is called the *curb*. This is either a wood or metal track which is normally built up in segments. There are three forms of curb: one is the dead curb which has the cap sliding round on the curb on well greased pads. This arrangement is the most difficult to turn. The live curb has the cap running on iron rollers, and the shot curb is one with a great number of small rollers. To centre the cap there are *truck* or *centering wheels* which run round the inner face of the curb.

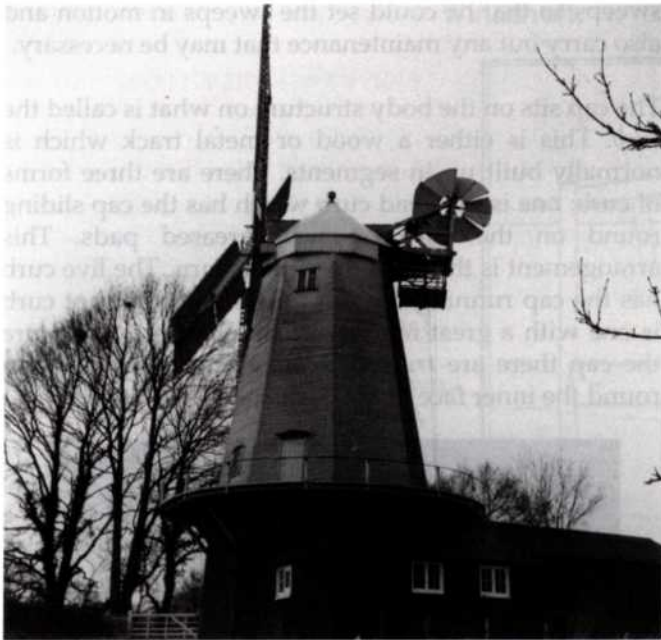
Fig. 12 Shipley Mill – fantail and staging

Those mills which have brick bases have heavy baulks of timber called *sills*, which are normally made of oak, resting on the top of the base wall and it is from here that the *cant posts* are erected these being braced into shape by beams of timber called *binders*.

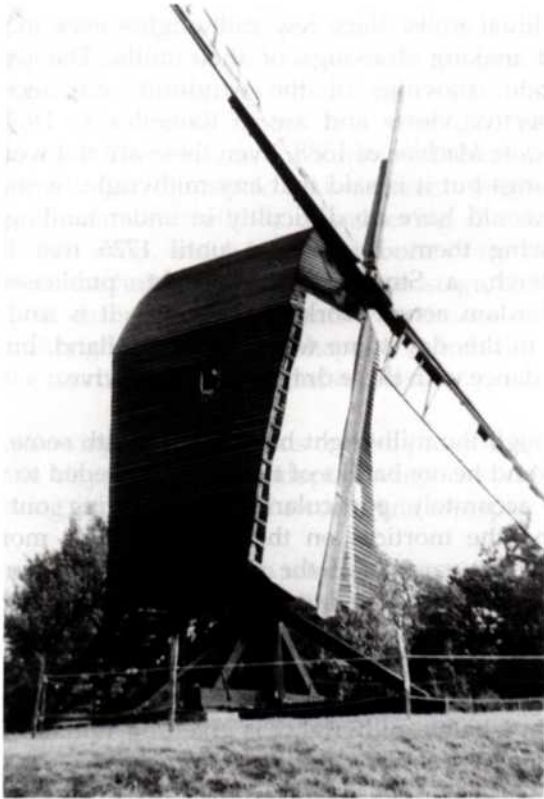
Fig. 15 Common and spring sweeps of Nutley Windmill (H. James)

Sweeps is the term used in Sussex for the sails of a windmill. These sweeps fall into three main types: common (canvas rigged), spring and patent or self-reefing. Some mills have a combination of common and spring sweeps as Nutley now has.

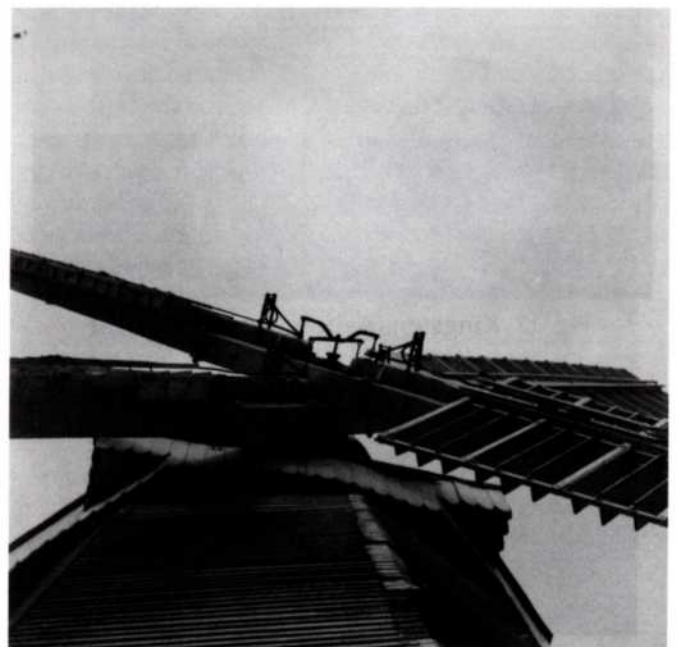
Fig. 16 Shipley Mill – patent sweeps

At one time common sweeps, with canvas spread by hand over each sweep frame, were universal. However in 1773 Andrew Meikle devised an alternative method. His idea was to have a series of transverse rectangular pivoted wooden shutters controlled by springs and adjustable levers very like the slats of a venetian blind. In 1807 William Cubitt, who was a millwright, coupled a weight and rod mechanism to a set of Meikle's spring sweeps and operated through a *striking rod* and *spider* which enabled all the shutters to be adjusted together. This modification became known as the *patent* sweep and was generally adopted for later windmills. The main advantage of this method of operation was that any adjustment to the shutters could be carried out without stopping the mill from working.

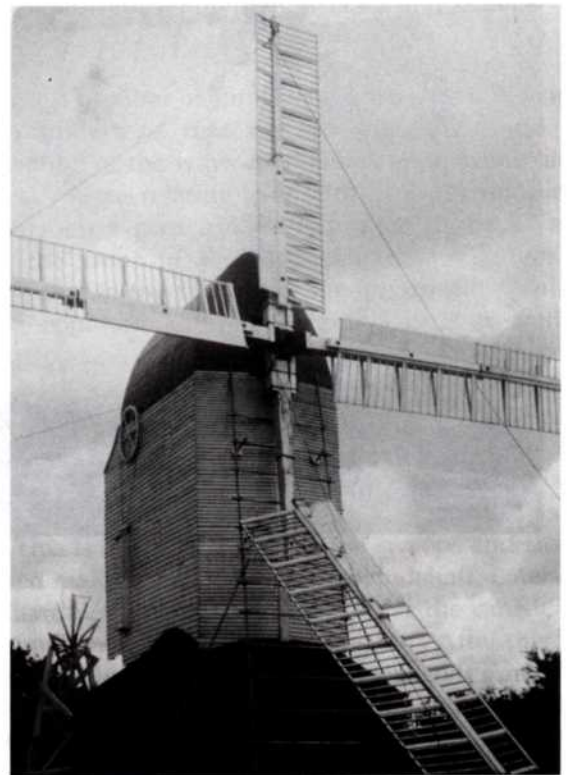
Fig. 19 Argos Hill Mill – first sweep being lowered

stock above the canister to which a pulley block is fitted so that it hangs on the outside of the canister. A steel hawser from one of the winches is reeved through the block and is secured carefully to the sweep which is about to be removed. A small length of chain is attached around the top of the *whip* and the hawser to help to keep a tight control when the sweep is being lowered.

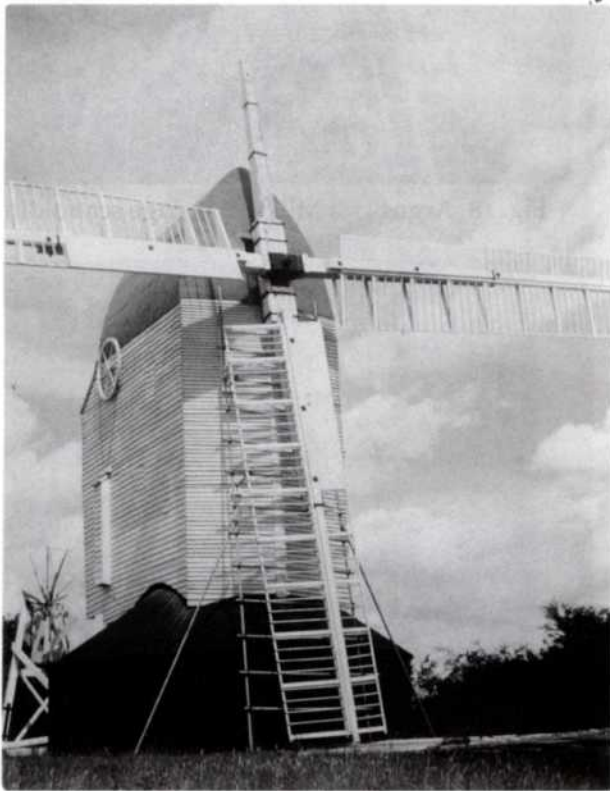
Fig. 20 Argos Hill Mill – second sweep being removed

6. When more than one sweep is to be removed the brake and securing lines have to be released with great care and control as the remaining sweeps are now out of balance and could easily swing out of control with dangerous consequences. With careful manipulation of the securing lines on the winches the sweeps are turned into the position for further removals. It is generally accepted that it is best to remove both sweeps from the same stock as this will reduce the effect of uneven weight distribution throughout the windmill.

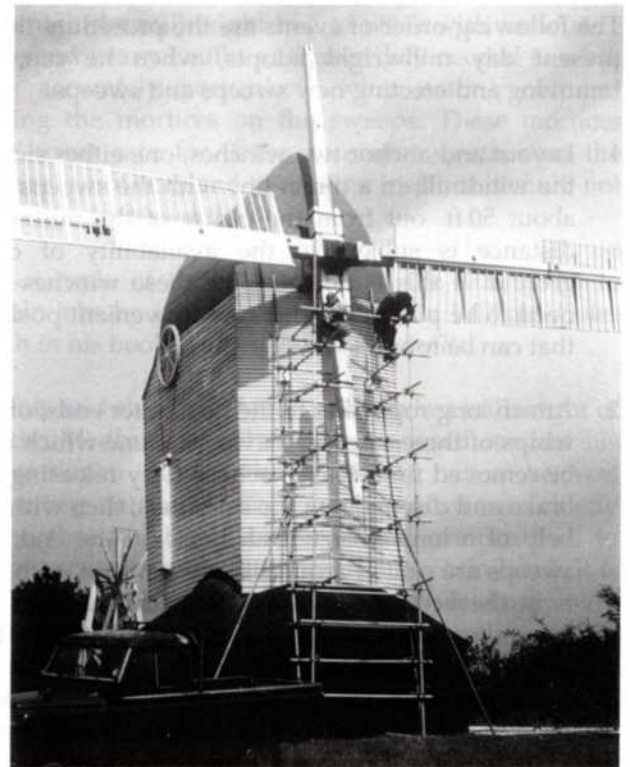
Fig. 21 Extra scaffolding being erected

8. The chain sling is again positioned but this time it is placed around the horizontal part of the canister and the pulley block is fitted so that it hangs at the front end a little lower than the bottom of the canister. The hawser is reeved through the block and attached to the stock using a convenient bolt hole that has been left by the removal of the sweep. As with the procedure for removing a sweep, a small chain is used to secure the hawser close to the stock to prevent it swinging out of control when it is being lowered. Once the hawser has been made safe the tension is taken up by the winches. When under tension the wedges and upper clamping blocks are removed from and around the canister. This will enable the stock to be lowered in easy stages.

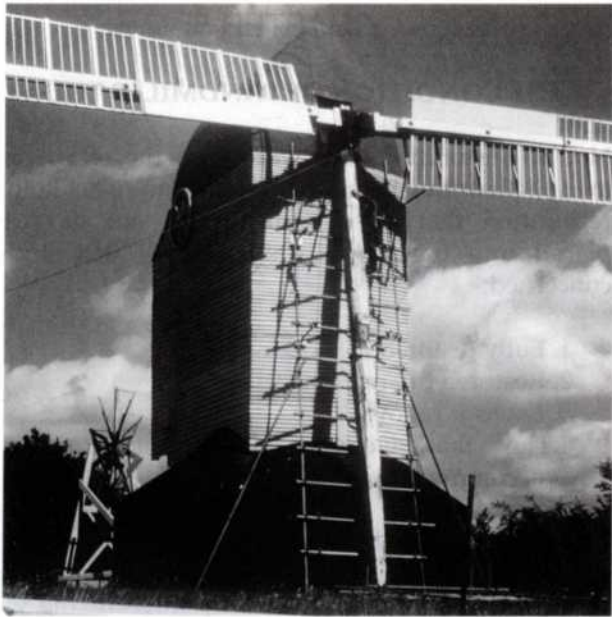
Fig. 22 Stock lowering

The stock is lowered until the bottom end is near to the ground when a heavy rope is attached to this end. With the upper end of the stock still supported in the canister, the brake and securing lines are slackened so that the existing sweeps can be revolved slightly.

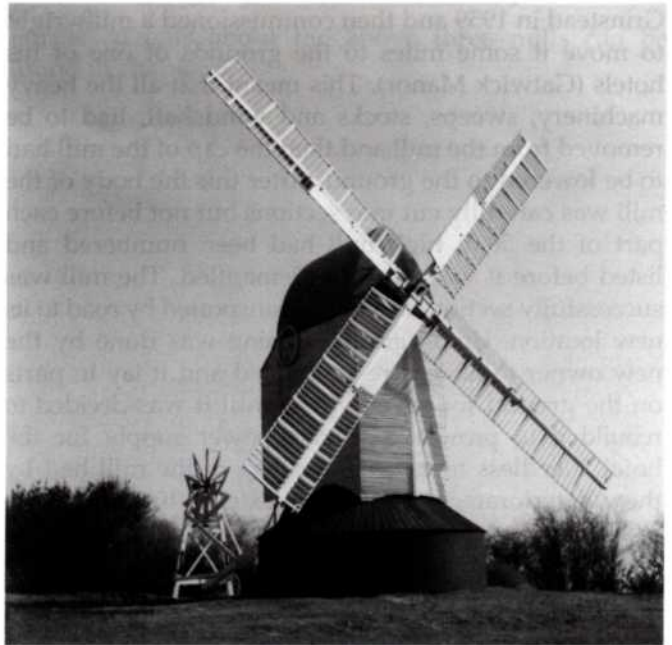
Fig. 23 Argos Hill with new stock and sweeps

11. Before the scaffolding is taken down it is helpful to fit the shutters to the sweep. This is only necessary when a particular design of the sweep calls for them. Any final touching-up with paint is completed and then the scaffold is removed. The sweeps are then revolved into the recognised parking position and the brake is re-engaged. This completes one of the more difficult jobs the millwright undertakes when repairing or restoring windmills.

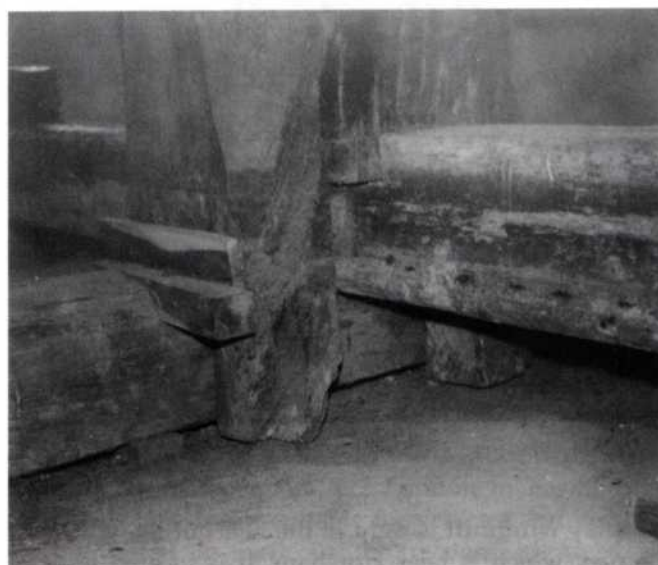
Fig. 32 Base of the High Salvington centre post

However this has since been disproved when a millwright was at work on the mill he was able to place his hand under the centre post. Fig. 32 shows distinctly the clearance under the centre post.

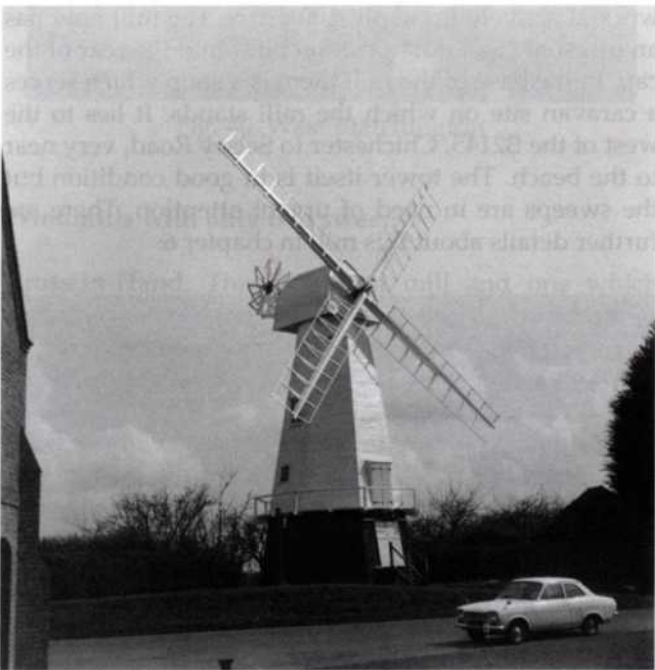
Fig. 33 Chailey

Chailey, North Mill. This is a smock mill and is located north of the A272, Haywards Heath to Maresfield road and nearly opposite the Chailey Heritage Craft School. The external condition of this mill is very good as it has recently had a "face-lift" when it was repainted in 1974. It possesses a fantail but there is no internal machinery. At one time it was used as a Boy Scout headquarters.

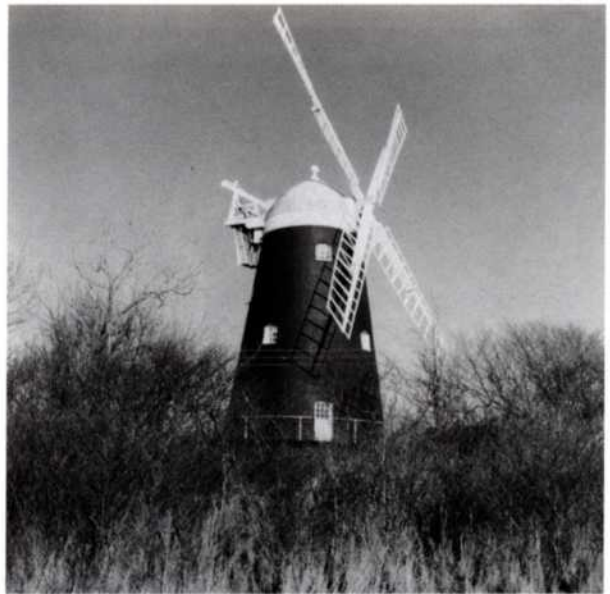
Fig. 34 "Jack", Clayton

"Jack", Clayton. This is a tower mill and it stands close to another windmill, "Jill" which is a post mill referred to earlier. These two windmills stand prominently on the South Downs at Clayton which is about seven miles north of Brighton on the A273 Burgess Hill to Pycombe road. The condition of "Jack" is good and he looks very smart with his gleaming cap and a set of open framed sweeps which were erected in 1973. There is no fantail or internal machinery.

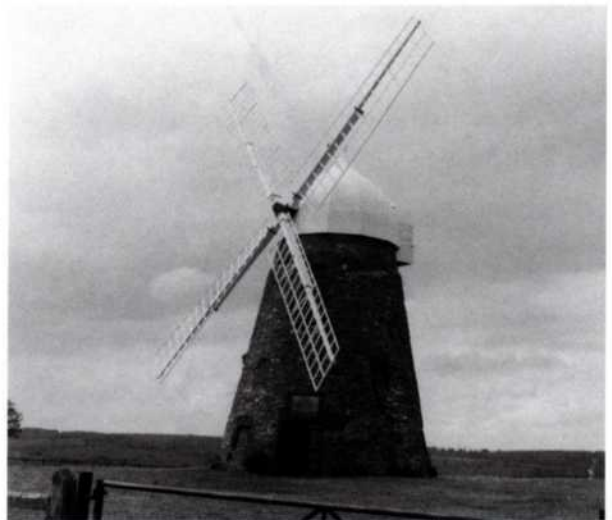
Fig. 35 Halnaker

Halnaker. A tower mill which is located high and exposed on the hills north east of Chichester and to the west of the A285, the Chichester to Petworth road. The exterior condition of this mill is good but it has no fantail or internal machinery.

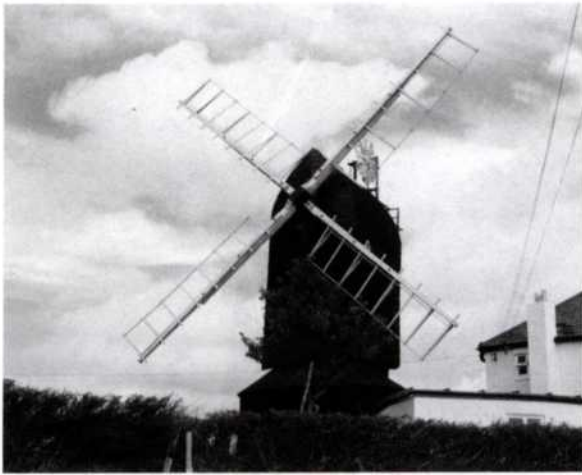
Fig. 36 Icklesham

Icklesham, Hog Hill Mill. A well preserved post mill of some particular note as it is considered to be the oldest post mill in Sussex being built about 1672. However it has not always stood in its present position. This mill possesses a fan tail which is attached in an unusually high position on the roof of the mill. This mill can be seen to the south of the A259 Rye to Hastings Road. It stands on private property adjoining a house.

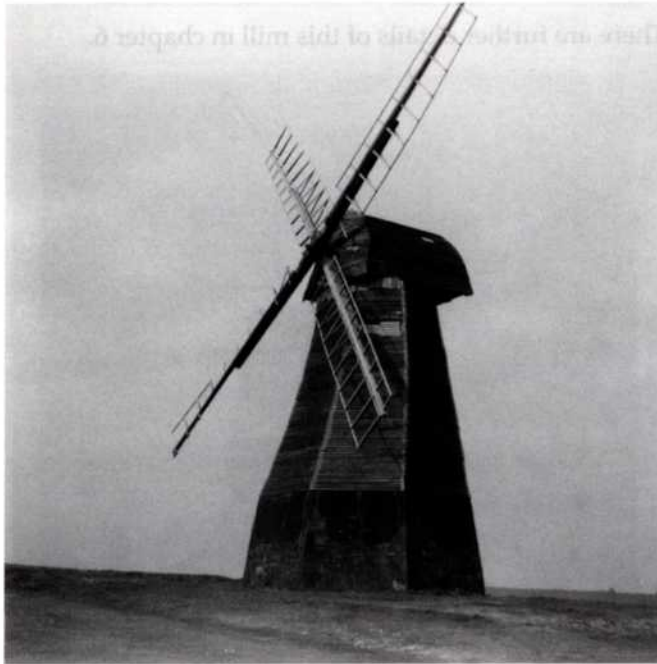
Fig. 37 Rottingdean

Rottingdean. This is a smock mill which is suffering from its exposed position, overlooking the sea, on the South Downs east of Brighton on the A259 Brighton to Newhaven road. This mill is in poor condition and is in the process of being renovated. There is no internal machinery and the inside has an extensive girder structure which supports the mill. There are further details regarding this mill in chapter 6.

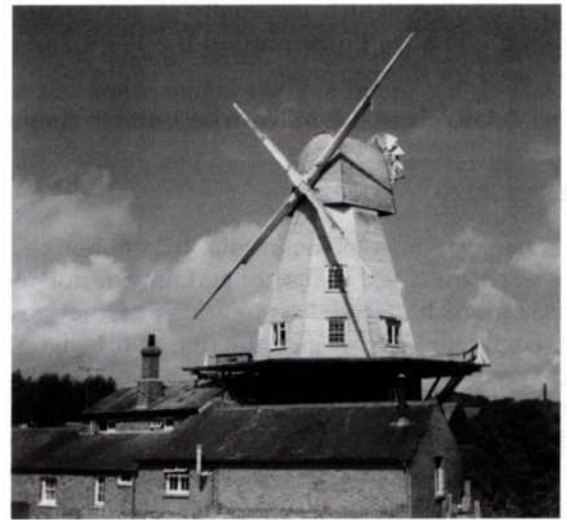
Fig. 38 Rye

Rye, Gibbet Mill. This is a smock mill and although it does not possess sweeps it has its stocks in place. The condition of this mill is good and it possesses a fine fan tail. It is located right in the heart of Rye and is the farthest west of the Sussex windmills. It stands just north of the A259 road.⁹

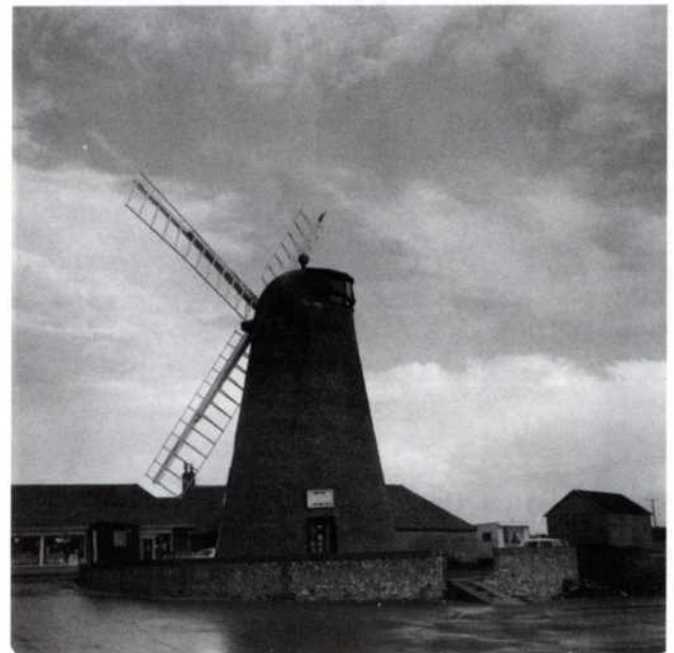
Fig. 39 Selsey

Selsey, Medmerry Hill. This is a tower mill which is thought to have been built around 1750 and has not worked actively for about 100 years. The mill now has an unusual "lookout" position built into the rear of the cap. In the base of the mill there is a shop which serves a caravan site on which the mill stands. It lies to the west of the B2145, Chichester to Selsey Road, very near to the beach. The tower itself is in good condition but the sweeps are in need of urgent attention. There are further details about this mill in chapter 6.

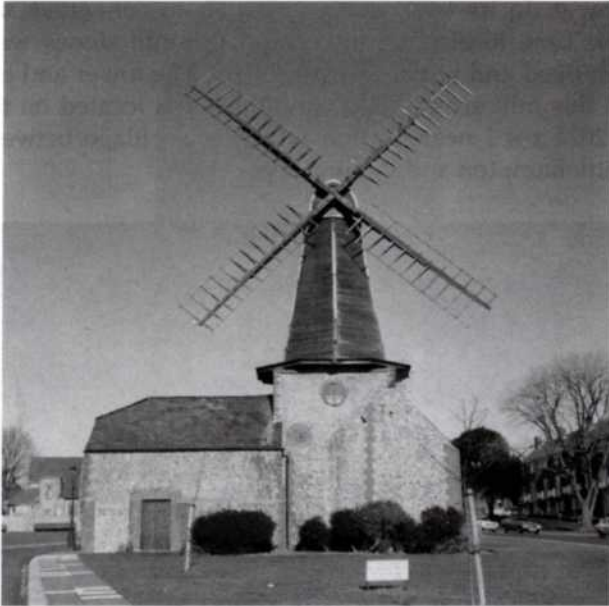
Fig. 40 West Blatchington

West Blatchington. This is a small and unusual smock mill which has six sides instead of the more usual eight. It has been built above what was a barn in which

the machinery was housed. It is located north of Hove on the north side of the A27 near Brighton. This mill is in a reasonable condition.¹⁰

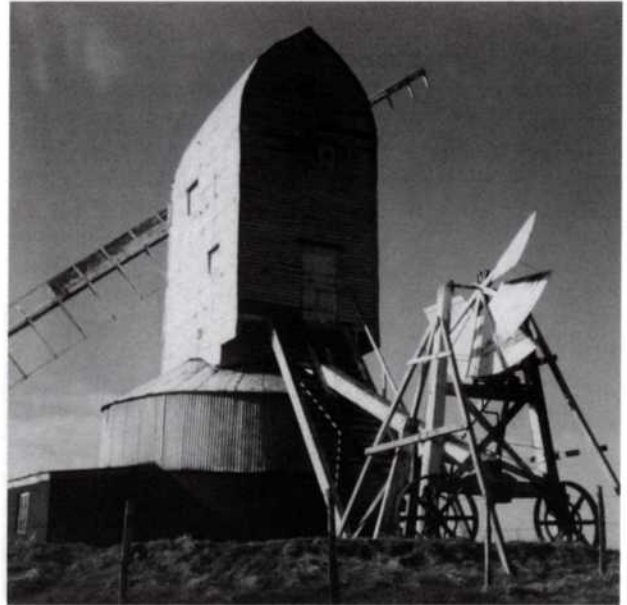
Fig. 41 Cross-in-Hand

Cross-in-Hand. This is a post mill and one which actively worked until 1969 and is the last windmill to work commercially in Sussex. An interesting feature of this mill is that it possessed a large tail pole fan tail similar to the one on Argos Hill mill. This mill is in poor condition and is badly in need of some urgent attention to save it from complete ruin. There have been several attempts to organise some renovation and East Sussex County Council have been approached to assist to these ends. The mill is located near the junction of the B2192 and the A267 roads near Heathfield.

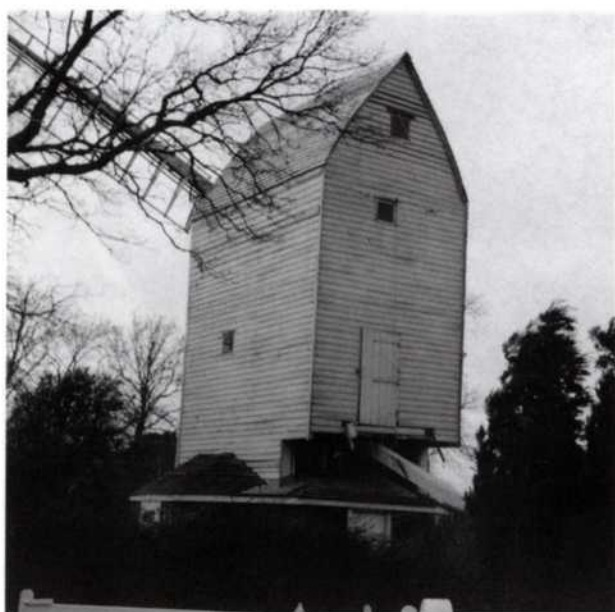
Fig. 43 Oldlands Mill

Oldlands, Keymer. A post mill which has a large floor area and said to be one of the biggest post mills in Sussex. It is maintained by the Sussex Archaeological Trust.¹¹ It is located north of the South Downs and is in the sight of "Jack and Jill" the Clayton windmills. This mill is in need of an external repaint and some structural repairs to prevent further deterioration from the weather.

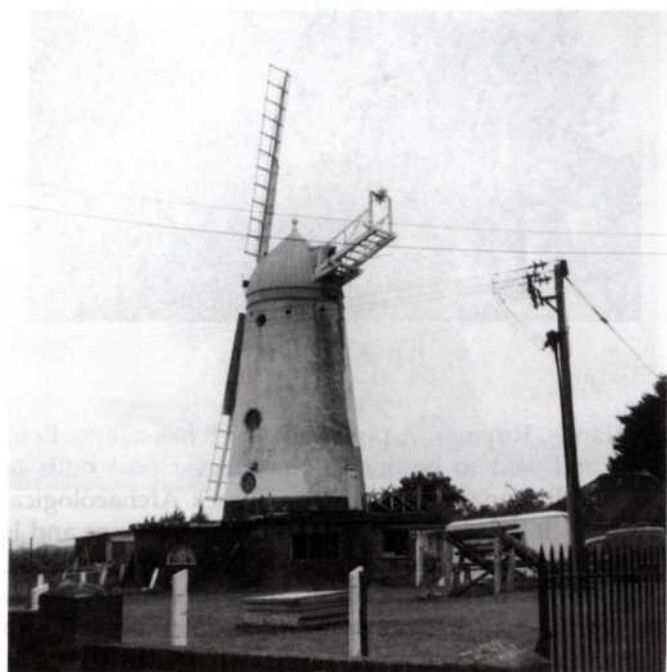
Fig. 44 Stone Cross

Stone Cross. A tower mill with an unusual shape to its windows which are round. It is located near to Eastbourne on the south side of the A27 Polegate to Pevensey road and it is close to where the B2104 crosses it. The mill is privately owned and is in the process of being renovated by the owner in readiness for its centenary, which is celebrated in 1975.¹² Two of this mill's sweeps were blown off in a gale in 1925 and that is how it has remained.

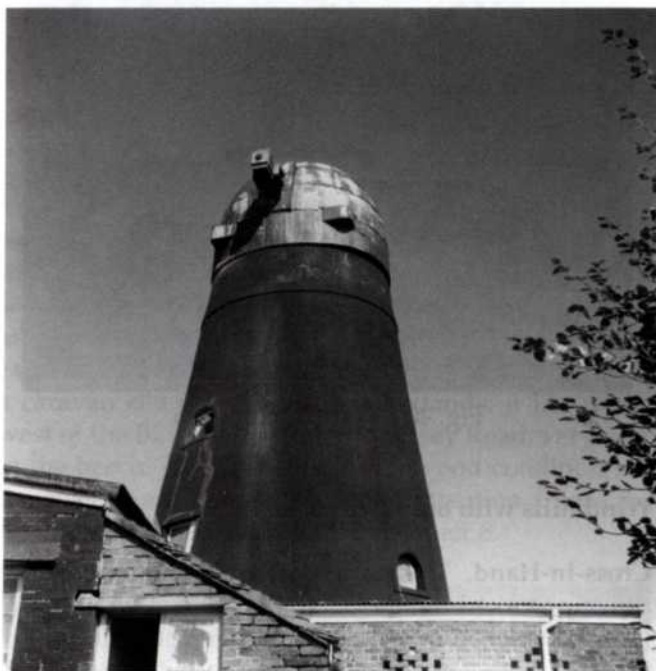
Fig. 45 Barnham

Barnham. A tower mill and one where the miller made valiant efforts to keep pace with the progress of time. The original mill was built around 1790 and after a century of work had a considerable re-fit. With the advent of gas-powered engines this mill had its sweeps removed and in 1910 was converted to this form of power. In its later years it was again converted and this time to electric power and the mill stones were removed and replaced with rollers. The tower and cap of this mill are in good condition. It is located on the A2024 road near Yapton which is a village between Littlehampton and Bognor Regis.¹³

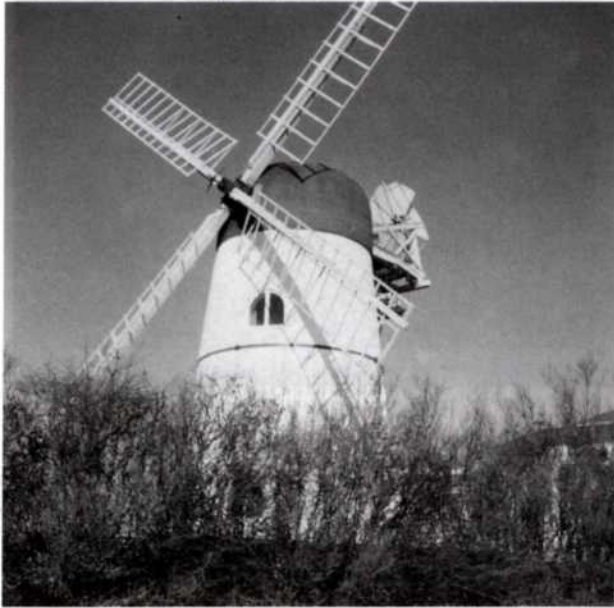
Fig. 50 Patcham

Patcham. A tower mill and the last windmill to be built in Sussex. It is in an excellent condition having had a large sum of money spent on it. It is located north of Brighton and stands in Mill Road which runs from Patcham cross roads on the A23, to West Blatchington. There are further details in chapter 6.

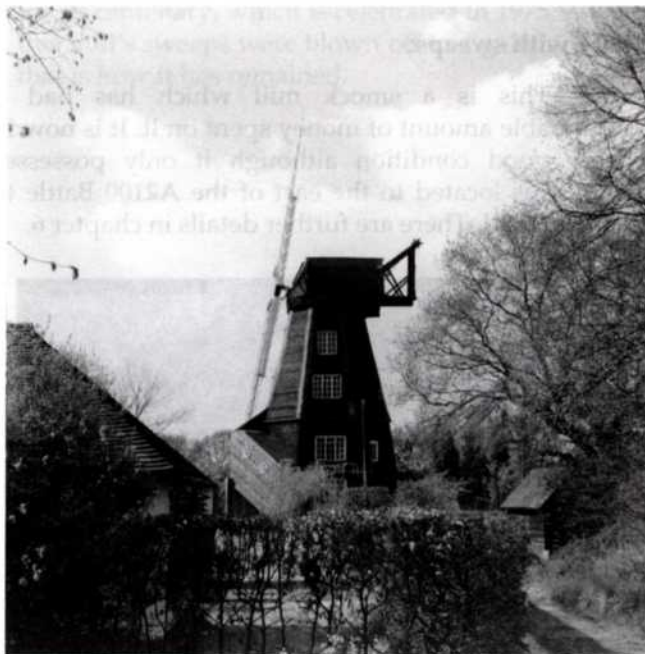
Fig. 51 West Chiltington

West Chiltington is a very old smock mill and it is said that it was built around 1688. It is in good condition but has only two sweeps and no fan tail. It is located in the village of West Chiltington near Pulborough. There are further details in chapter 6.

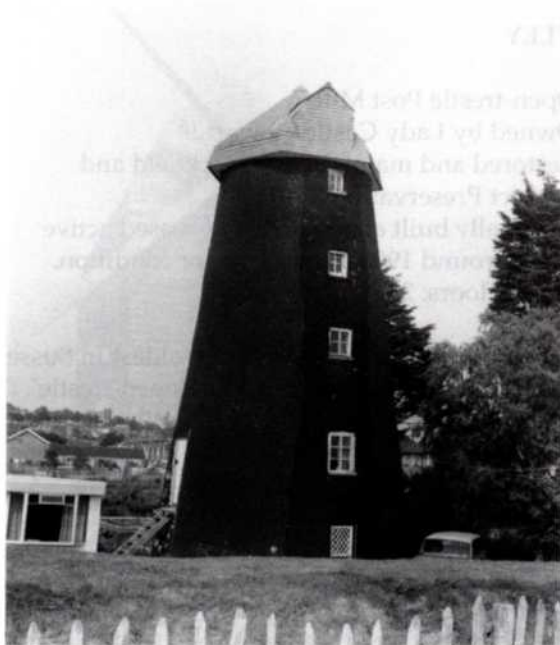
Fig. 54 Arundel

Arundel is a tower mill which stands by the River Arun just south of the A27, Arundel bypass. The tower looks in a reasonable condition.

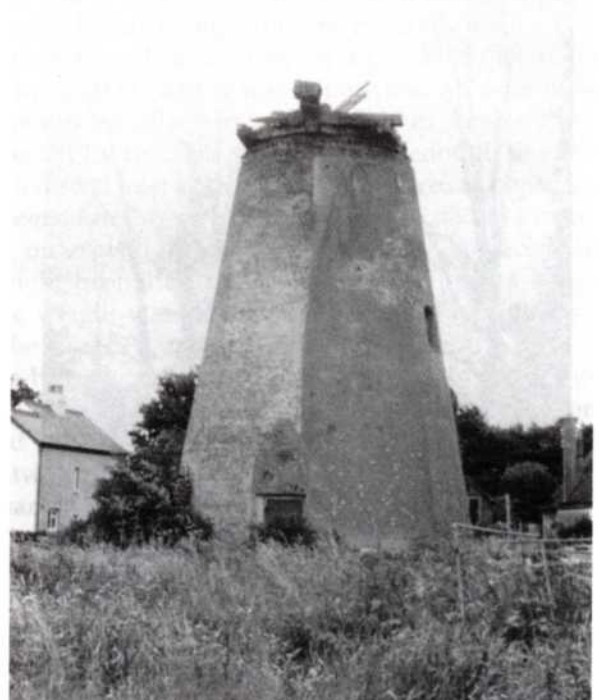
Fig. 57 East Wittering (Peter Hill)

East Wittering. This mill ceased active work in 1891 when an accident damaged the fan. It has been sweepless since 1926. The cap and fan tail of this mill were blown off in a gale around 1930.

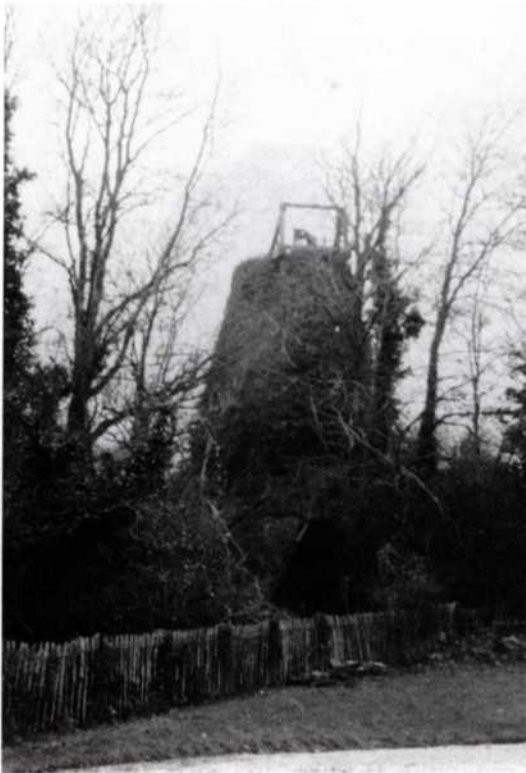
Fig. 59 Nyetimber (Peter Hill)

Nyetimber. This mill ceased active work in 1915. It was finally destroyed by fire in the mid 1960s.

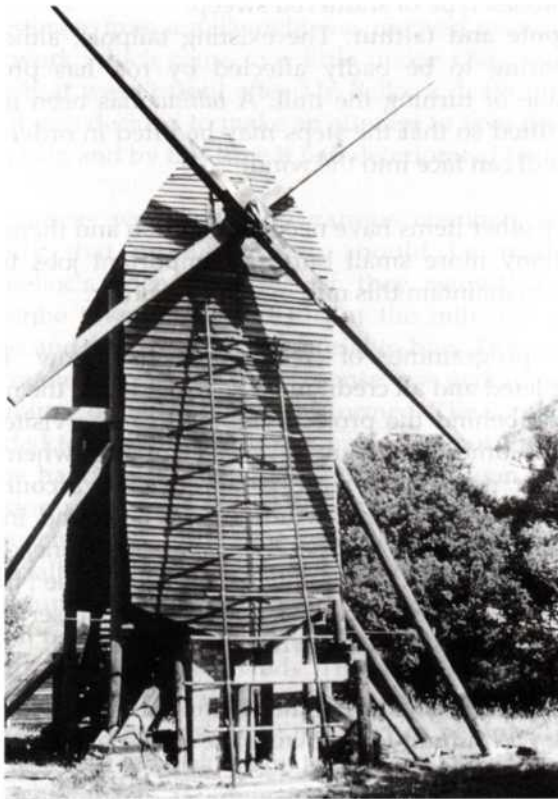
Fig. 60 Nutley Mill –
showing the two brick piers (Brian Austen)

It wasn't until 1929 that the present owner, Lady Castle Stewart, put into effect the instructions to radically strengthen the whole structure. This was done by building two brick piers which were supported by steel girders and were erected under the front part of the mill by using four stout wooden posts at the rear – this preventing the imminent collapse of the trestle. A new set of sweeps were put up at the same time and, except for a period during the 1939-45 war, the mill has worn a set of sweeps ever since. A further piece of restoration was also completed and this was to clad the outside of the mill with another layer of overlapping boarding. This served two purposes; one to prevent the weather getting at the body structure and the other to give it more rigidity.

It started to suffer drastically from decay and structural failures towards the end of the nineteenth century. One of the critical structural weaknesses occurred in the side girts with the subsequent distortion of the front corner posts. The whole of the front of the mill began to collapse and this caused the *sheers* to crack. An effort was made to strengthen the whole of the front of the mill to prevent the *breast beam* from falling out.

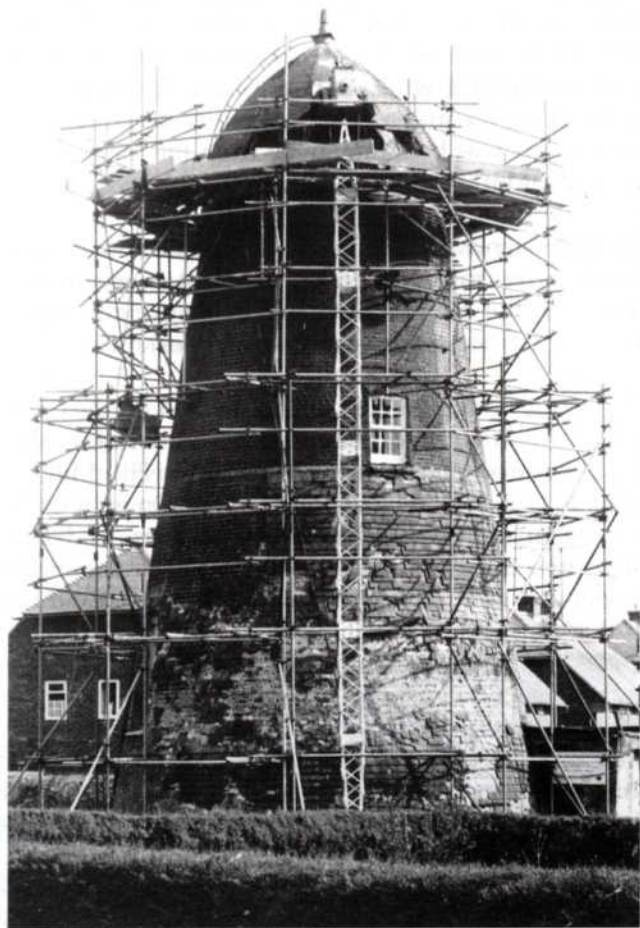
Fig. 65 Polegate – Renovations in progress
(Lawrence Stevens)

Fig. 65 shows the extent of the scaffolding required by the millwright and the *jib and jack* under the canister.

With further jacks inside the mill the cap and windshaft were raised enough to allow the fan-staging to be fitted. Once this had been completed work commenced on the cap itself. This required certain replacements to roof ribs and a complete covering with new boarding, finally a covering of two layers of roofing felt was laid, the top one being treated with a white mineralised compound giving the cap its original white appearance. These two major items completed, the millwright turned his attention to the sweeps, little more than a routine task for him and his

men apart from the fact that the condition of the old sweeps was far worse than had first been thought. It was found necessary to renew one of the stocks and two of the sweeps completely and make substantial repairs to the remainder.

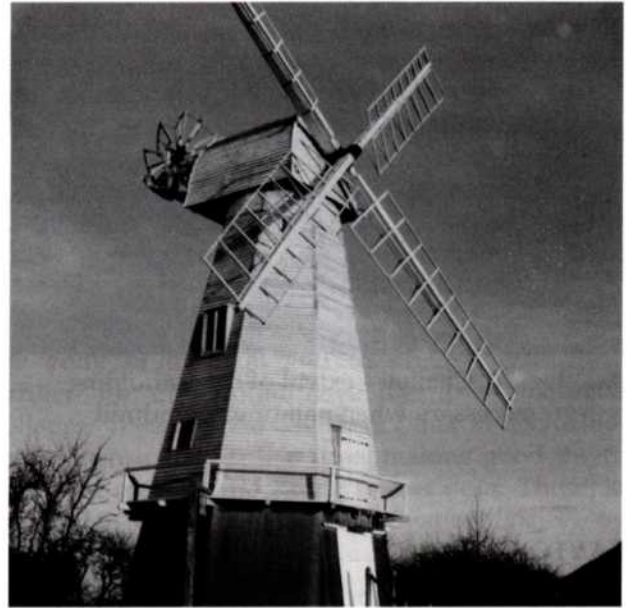
Fig. 69 Chailey before face-lift

This mill was given a complete face-lift when it was repainted in 1974. Fig. 69 shows the mill before the face-lift.

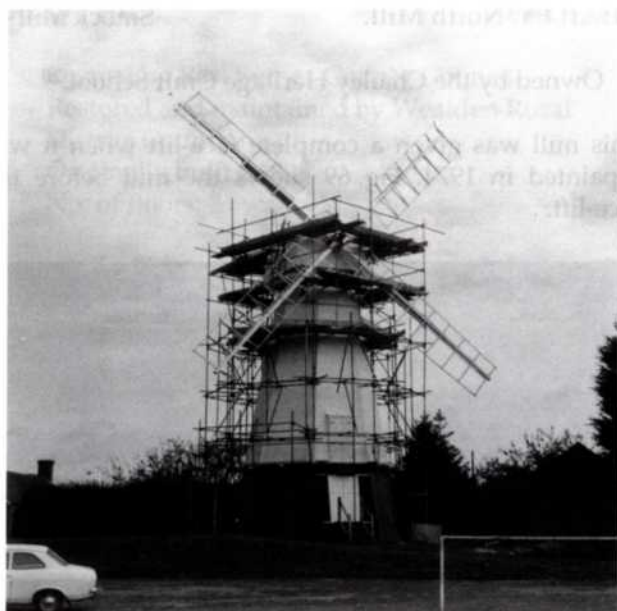
Fig. 70 Chailey – extent of the scaffolding necessary when painting a windmill

To paint a windmill like this could cost as much as £1,200. It is necessary to hire scaffolding and this alone could cost £300 per month so you can see that this is an expensive business. Fig. 70 shows the extent of the scaffolding required when painting the exterior of a windmill.

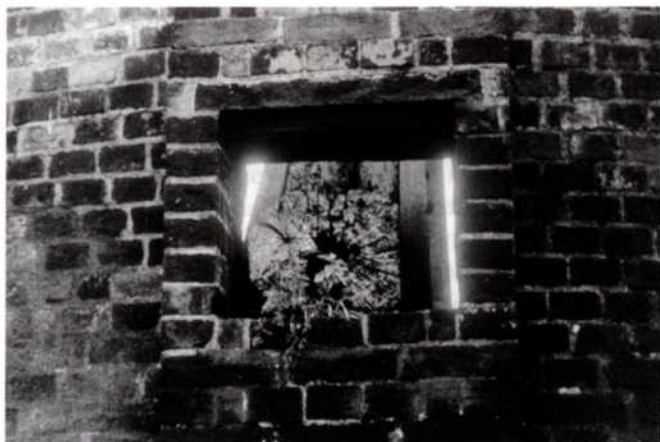
Fig. 71 Cross tree protruding through the roundhouse wall, Lowfield Heath

Lowfield Heath is a post mill and the most northerly of the Sussex windmills. Its condition is deteriorating as the roundhouse has no roof to it and the trestle is exposed to the weather. Apart from this the mill is in a reasonable state but it really needs attention as soon as possible to prevent further damage. It is located on the A23 just south of Gatwick Airport between Horley and Gatwick.¹⁴

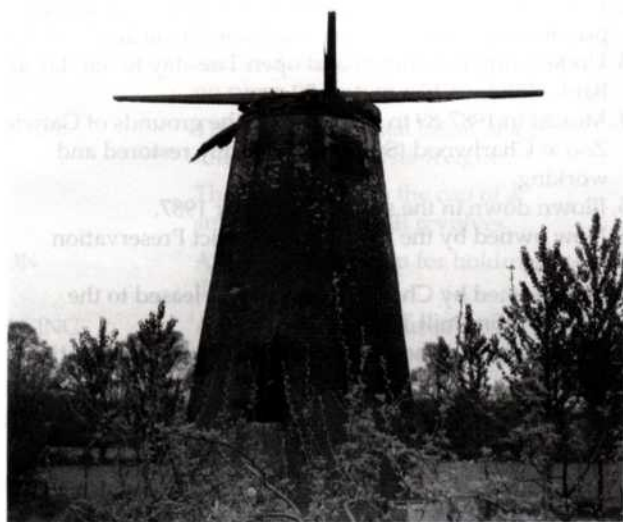
Fig. 72 Nutbourne – A derelict windmill

The weather also had a hand in the decline of active windmills because of deterioration of the moving parts particularly sweeps, shutters, and fantails. To maintain and replace such parts cost the miller a considerable amount of money, and without the business coming their way, they were unable to keep their mills in good working order.
